Valli Vue Estates Property Owners Association

August 11, 2023

The Board of Directors for the Valli Vue Homeowners Association (HOA) is submitting this letter on behalf of the residents of the Valli Vue neighborhood to express deep concern over the project undertaken to rehabilitate our ditches, which began in the summer of 2022 and completed in June 2023. We are seeking extensive remediation. The Valli Vue neighborhood is centered along Main Tree Drive north of O'Malley Road and is home to 227 households. In lieu of Valli Vue households submitting individual comments and letters to the Anchorage Mayor and our Assembly representatives, the HOA has compiled this letter from the voices of all our concerned households. 137 households have signed this letter attesting their agreement with the below concerns and the request for remediation.

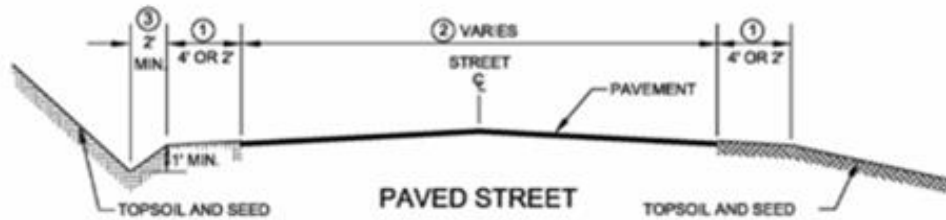
Figure 1. Municipality guidance for streets like those in Valli Vue

The ditch configuration is now at odds with the Municipality's guidance for rural streets such as ours (see Figure 1). The guidance depicts a 2-foot shoulder approximately flush with the road surface followed by a ditch as shallow as 1 foot lined with topsoil and grass. In practice, a 1-foot shoulder seems typical (as seen on East 99th Ave, Homestead Trail, and Meridian Way/Zenith St), and our shoulders were about that wide before excavation. The depth of our pre-existing ditches was already close to the 1-foot minimum in most cases. A compelling case has not been made to justify the magnitude of the present project in contrast to a much smaller effort that would have conformed with the guidance. Given the safety problems with the current effort, restoring perceived original contours of nearly 50 years ago is nonsensical. The ditch project should have been based on the current guidance and only addressed areas that needed attention, not 100 percent of the ditches.

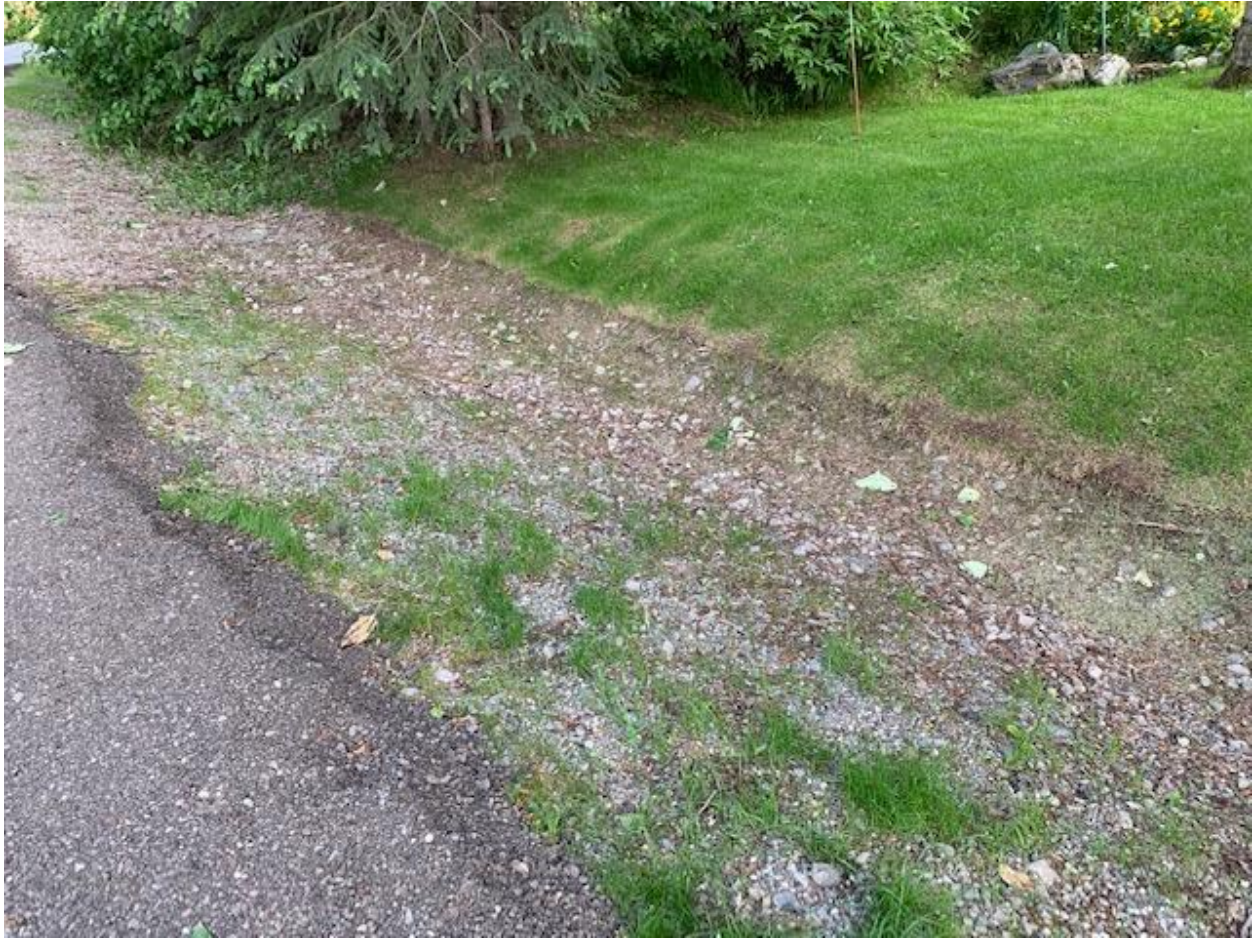
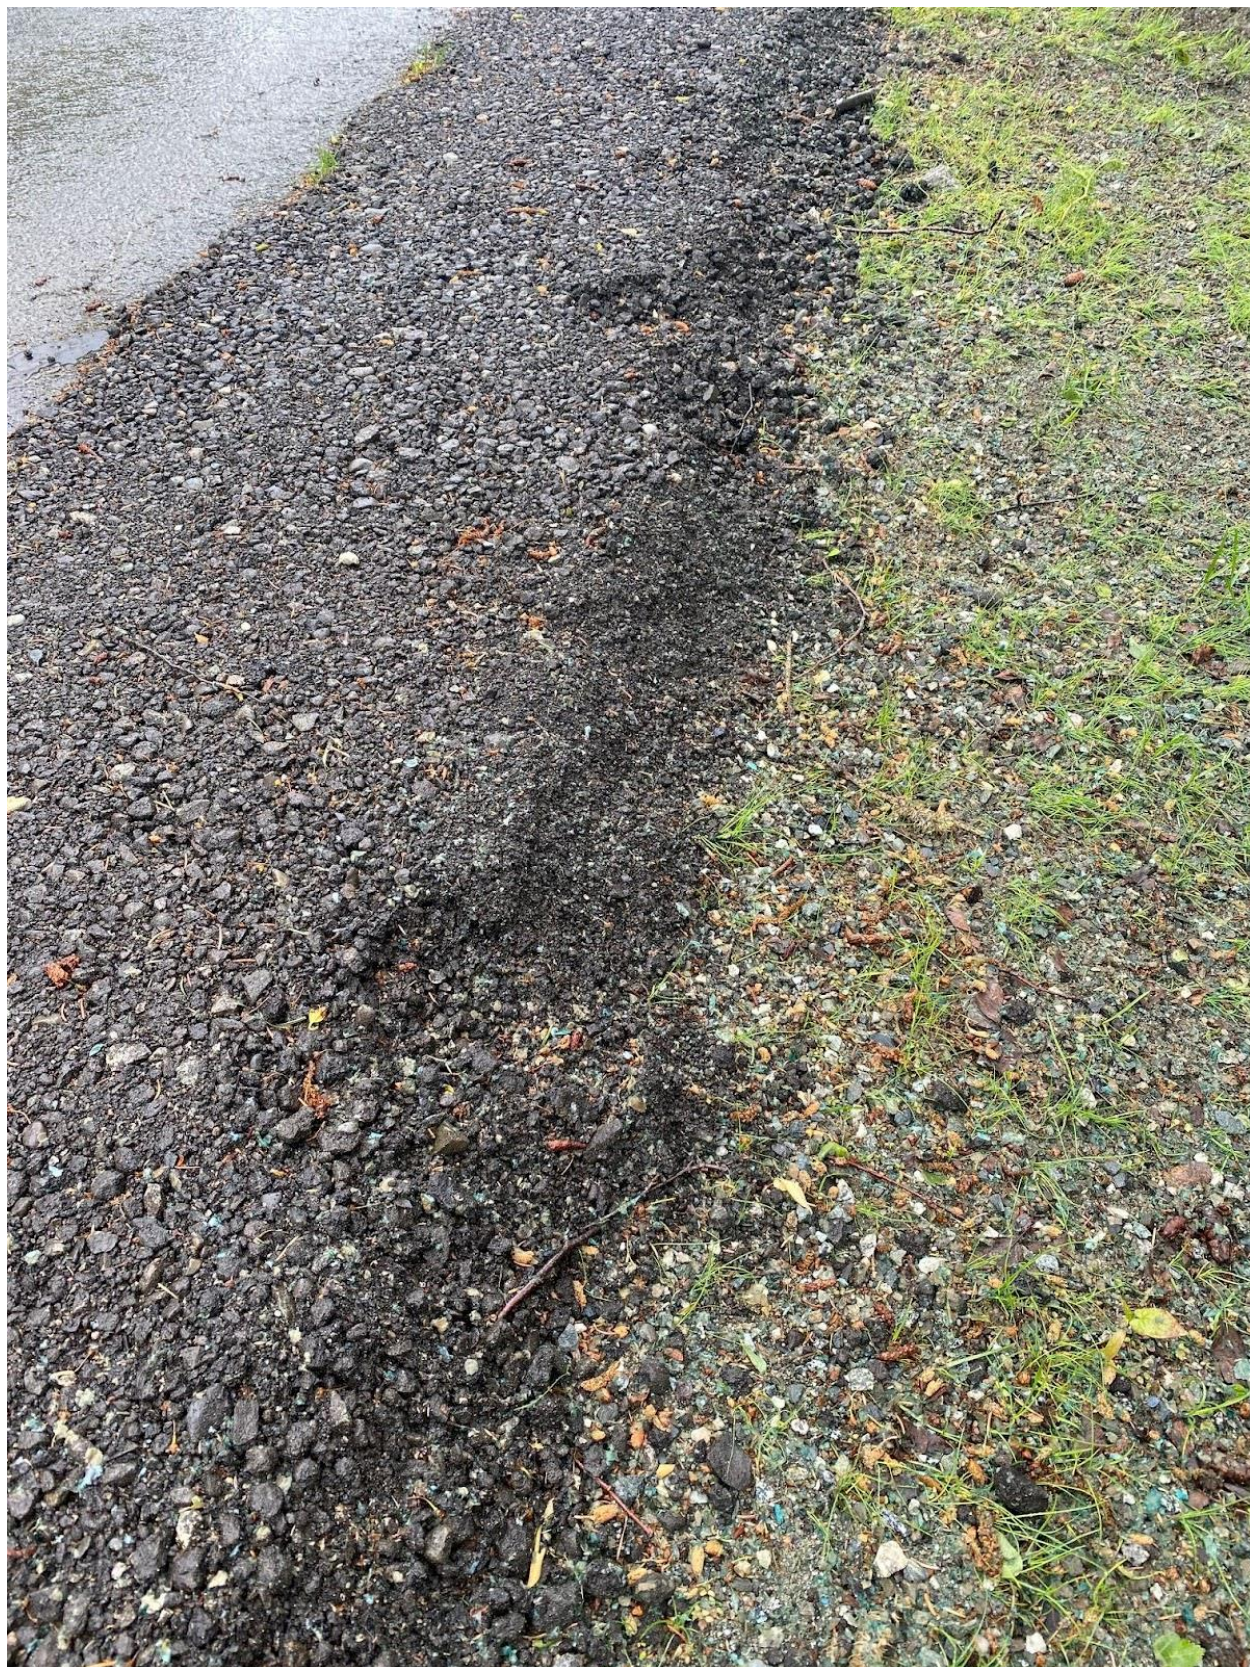
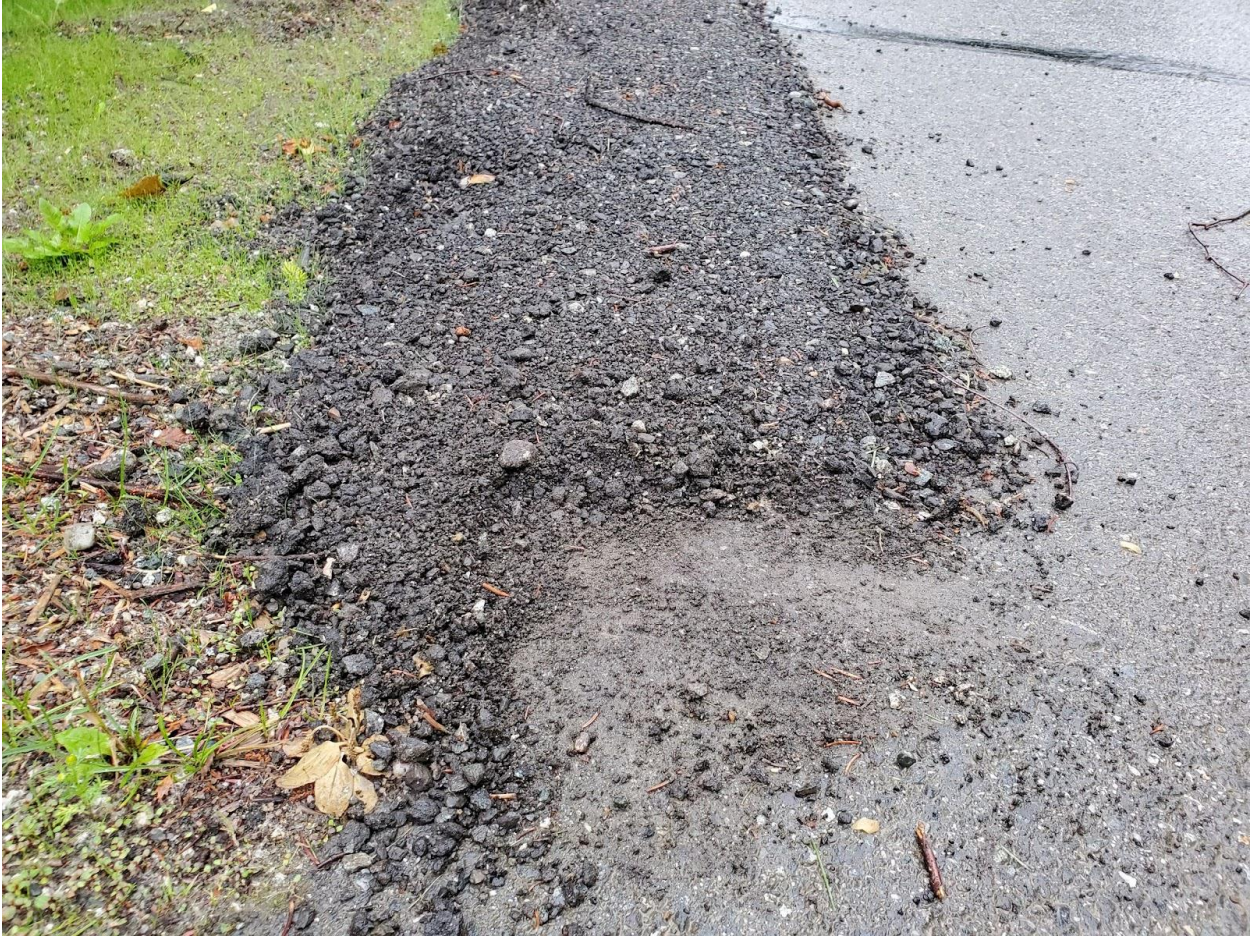
In addition to the structural and visual impacts identified, the contractor and the Municipality likely violated local, state, and federal environmental regulations in storm water management. All projects exceeding one acre of ground disturbance must obtain authorization under the Alaska Pollutant Discharge Elimination System (APDES) Construction General Permit (CGP). As part of this authorization, a Notice of Intent must be filed with the Alaska Department of Environmental Conservation (ADEC) as well as the preparation of a compliant Storm Water Pollution Prevention Plan. We understand that no authorization was obtained and that a proper SWPPP was not prepared. The Municipality also regulates storm water management through AMC Title 21 and during the construction of its own (public) projects through Section 20.02 of its Standard Specifications. This non-compliance results in a violation of the Clean Water Act, creating a liability for the Municipality, the HOA, and the affected homeowners. At a minimum, the

revegetation effort failed as the 70% reestablishment of grass did not occur and weed-free, Alaska-native seed does not appear to have been used.

1. Restoration of 2-foot shoulders (or greater) using material other than RAP as soon as possible.
2. Reduction of ditch depth to no more than 1.5 feet before topsoil placement, where practical (e.g., away from culverts).
3. Final contouring and cleanup; to remove loose rocks, roots, culvert heaters, and smooth the transitions to adjacent landscaping.
4. Addition of a suitable thickness of topsoil and seeding with quality grass.
