September 24, 2022

**Subject: Concerns about the Valli Vue LRSA ditch rehabilitation project**

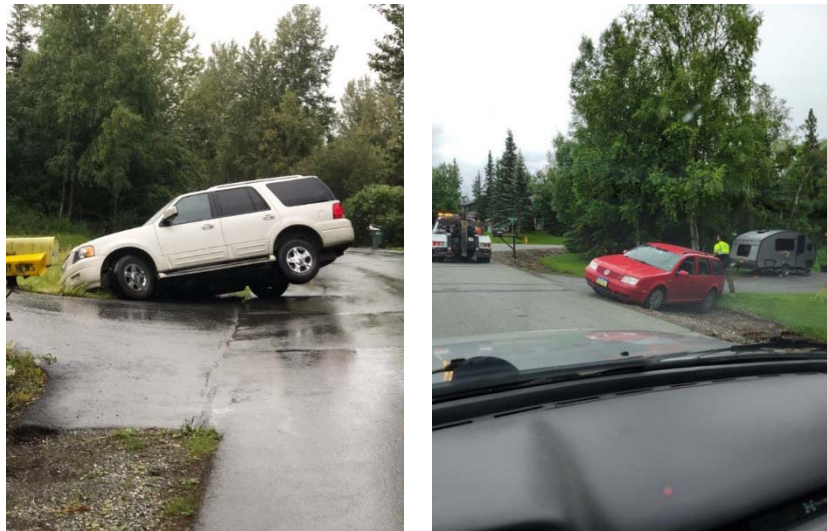
1. **The ditches have become a driving hazard.** Already, at least two cars have been ensnared (see Photo 1), and in winter when the ditches are plowed flush with the road, they will be camouflaged pit traps. In some places, the deepened ditches may present a rollover hazard to cars and school buses.

Photo 1. Cars in ditches in August and September 2022

1. Restoration of 1-foot shoulders (or greater) as soon as possible, preferably before winter.

2. Reduction of ditch depth to no more than 1.5 feet before topsoil placement, where practical (e.g., away from culverts).
3. Final contouring and cleanup to remove loose rocks and roots and smooth transitions to adjacent landscaping.
4. Addition of a suitable thickness of topsoil and seeding with grass.

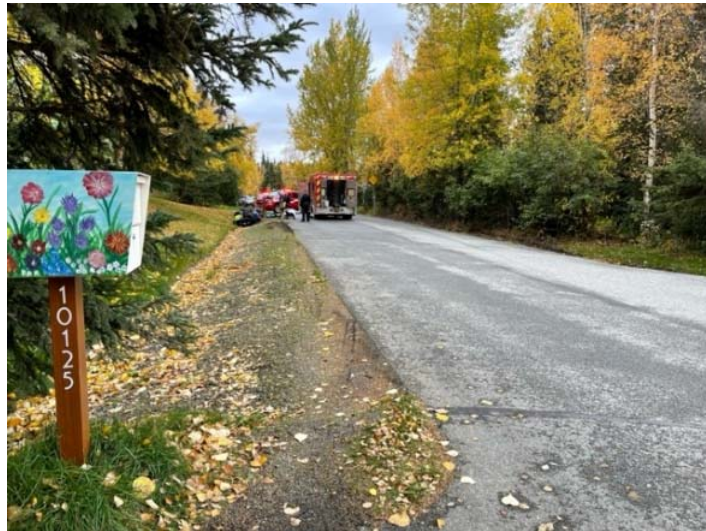
2. **The absence of a shoulder has decreased pedestrian safety.** Previously, people could easily step off the pavement or even walk on the shoulder to put a little space between themselves and traffic. Sadly, one of our older residents was out walking on Main Tree Drive in the afternoon on September 21<sup>st</sup> when he was hit by a car (see Photo 2); the severity of his injuries has not been made public.

Photo 2. Pedestrian hit-and-run 2022-09-21 on Main Tree Drive

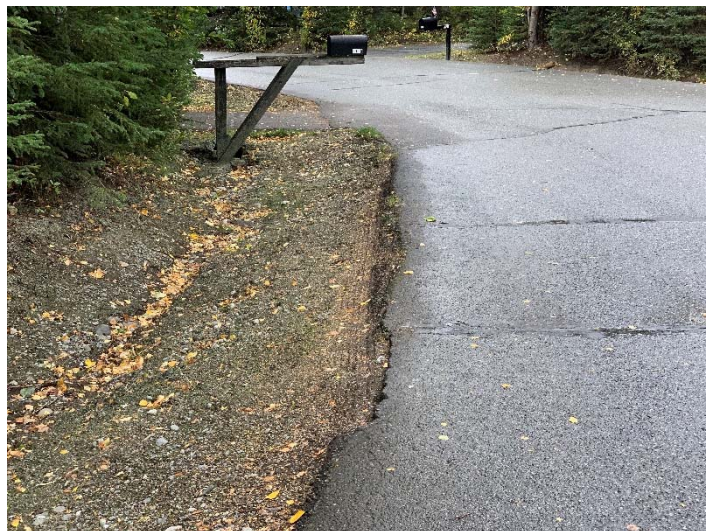
3. **Our pavement is at risk.** Without a shoulder adjacent to the pavement edge, vehicles are beginning to break down the edge (see Photo 3). In contrast, the extent of pavement degradation due to roadbed saturation appears to be negligible based on the absence of frost heaving or areas with excessive cracking.

Photo 3. Pavement edge damage by traffic (mail truck)

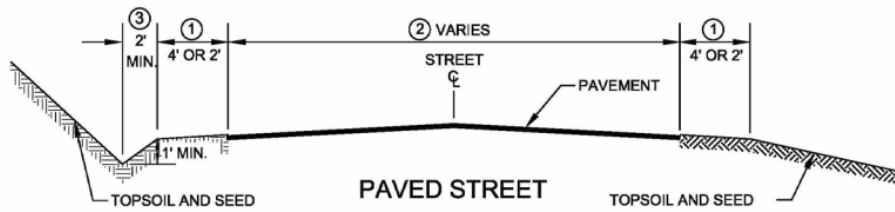
FIGURE 1-14 RURAL SECONDARY STREETS

The present ditch configuration is also at odds with the Municipality's guidance for rural streets such as ours (Figure 1). The guidance depicts a 2-foot shoulder approximately flush with the road surface followed by a ditch as shallow as 1 foot lined with topsoil and grass. In practice, a 1-foot shoulder seems typical (as seen on East 99<sup>th</sup> Ave, Homestead Trail, and Meridian Way/Zenith St), and our shoulders were about that wide before excavation. The depth of our ditches was also close to the 1-foot minimum, which could have been achieved with minimal digging. An effective case has not been made to justify the magnitude of the present project in contrast to a much smaller effort that would have conformed with the guidance. Given the safety problems with the current effort, restoration of perceived original contours of nearly 50 years ago is nonsensical. The ditch project should have been based on the current guidance.

Figure 1. Municipality guidance for streets like those in Valli Vue
